Transportation Safety Board
of Canada

AVIATION INVESTIGATION REPORT
A01O0299

RUNWAY INCURSION

BETWEEN AVITEC TRACTOR 197
WITH AIRBUS A310 IN TOW
AND
AIR CANADA BOEING 767-200 C-GAUH
TORONTO/LESTER B. PEARSON INTERNATIONAL
AIRPORT, ONTARIO
23 OCTOBER 2001

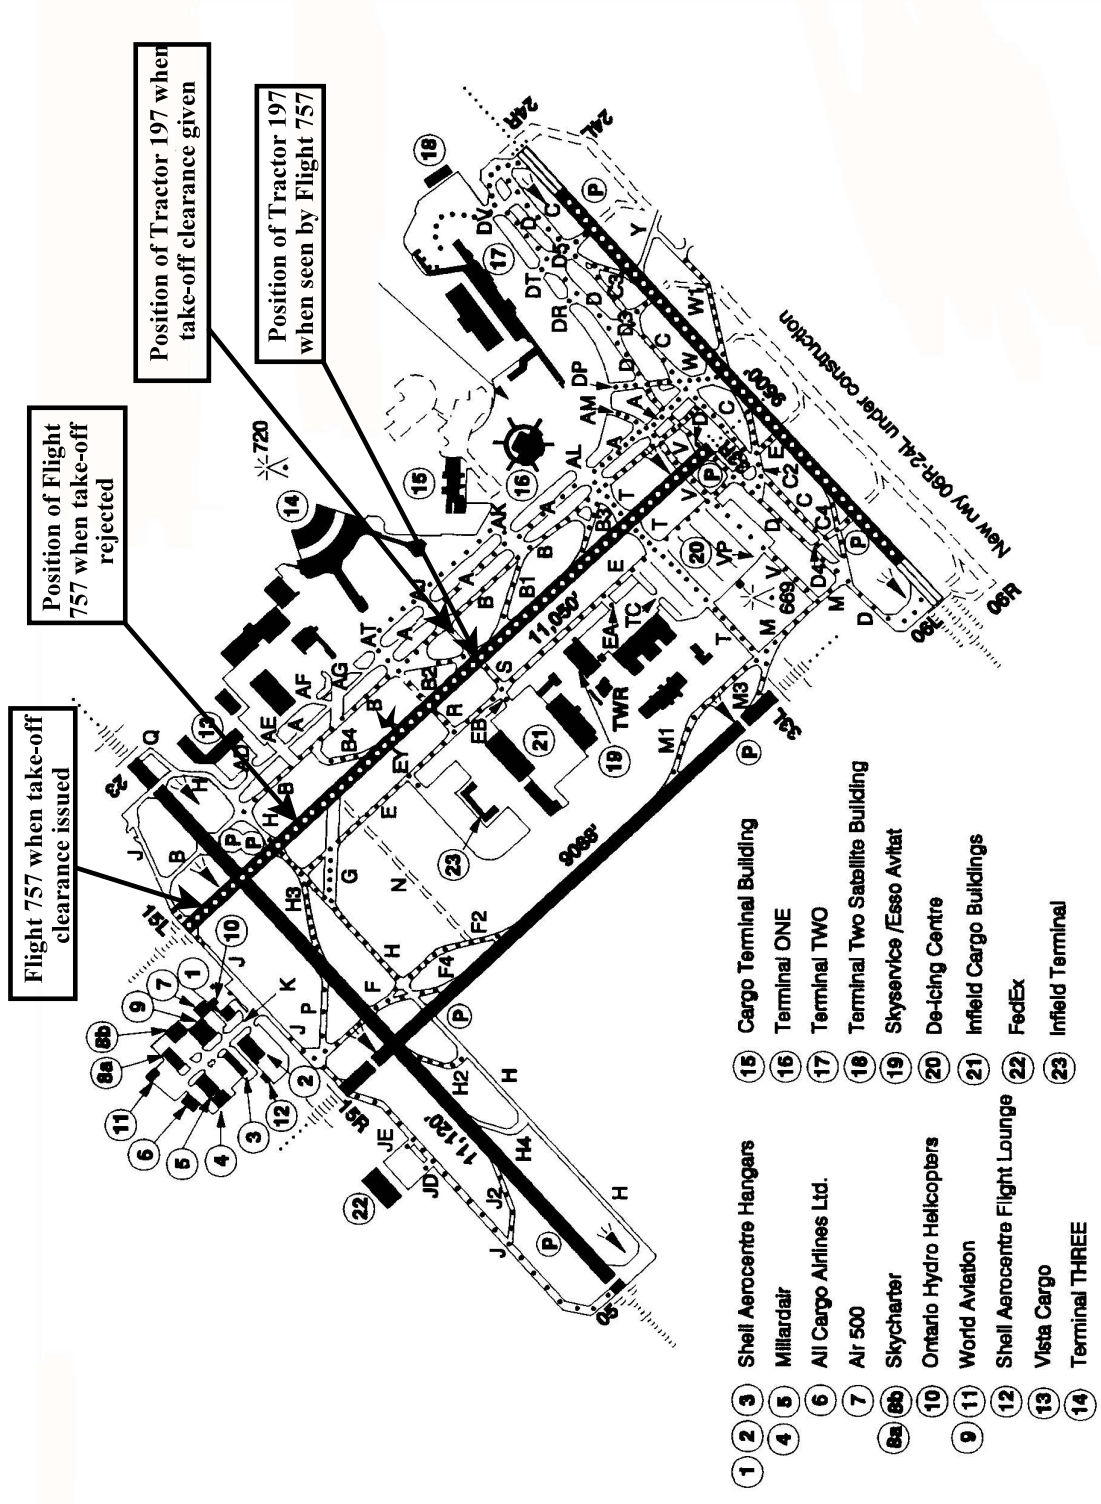
Appendix A – Airport Diagram with Positions of the Aircraft and the Tractor

Avitec Tractor 197 was towing an Air Transat Airbus A310 aircraft from Terminal 3 on the east side of Toronto/Lester B. Pearson International Airport to the central de-icing facility on the west side of Runway 15L. The tractor driver had received and acknowledged authorization to tow via taxiway Sierra (which crosses Runway 15L) and taxiway Echo, to hold short of taxiway Tango. At the same time, Air Canada Flight 757, a Boeing 767-200 aircraft, was cleared to position on Runway 15L. A minute and a half later, Flight 757 was cleared for take-off. At that moment Tractor 197 was crossing the hold line on taxiway Sierra, proceeding to cross Runway 15L in accordance with his authorization. The tractor driver saw Flight 757 in position on the runway but did not perceive it to be in motion until he was fully onto the runway and in a position where he had no alternative but to continue to cross in order to vacate the runway as quickly as possible. After commencing their take-off, the flight crew of Flight 757 observed the tractor and tow entering the runway. They rejected the take-off, reaching a speed in excess of 90 knots approximately 2500 feet down the runway, 3500 feet from taxiway Sierra. When Tractor 197 cleared the runway, the aircraft had slowed to less than 40 knots and was 1000 feet from taxiway Sierra. Flight 757 cleared the runway at taxiway Sierra.
